Damage & Capacity Assessment

PORT OF ADEN AND PORT OF MUKALLA

Henk Engelberts and Marc Wormmeester

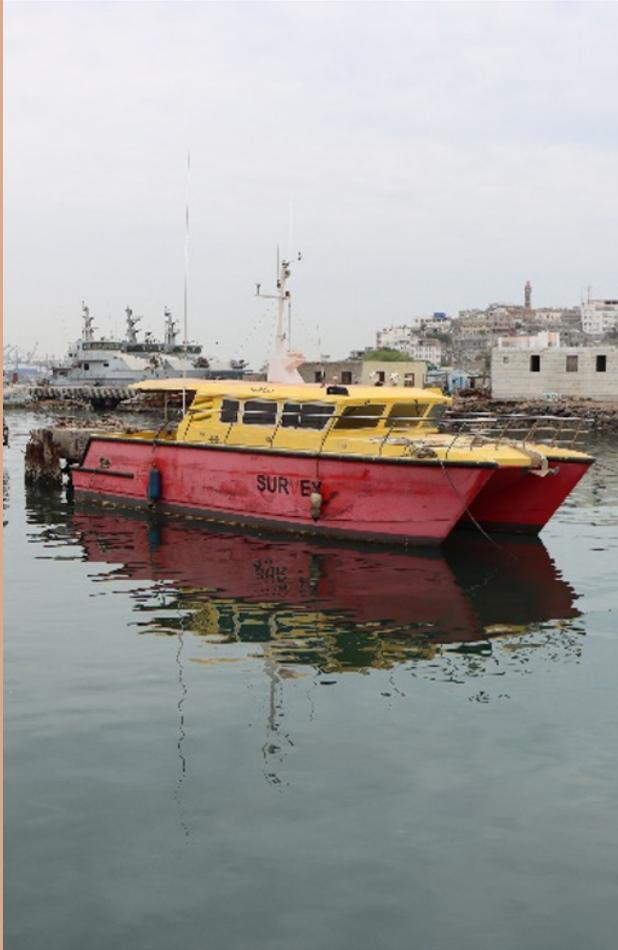
In 2014, a survey vessel and equipment were purchased to carry out hydrographic surveys of the harbour bottom and berths. This vessel was delivered, but to date staff have not received training in either the use of the equipment or how to create hydrographic maps. Despite requests from the YGAPC for supplier-led training, bringing the experts to Yemen has been challenging. As such, the vessel has gone unused for years and YGAPC is unaware of scour on the bottom of the berths that may pose a risk to the structural integrity of the quay walls. They also cannot track spills or objects that may become navigational obstacles.

Figure 3: Survey Vessel | Photo: Port of Rotterdam

RECOMMENDATION: The YGAPC would like a new dredging vessel. To make optimal use of new dredging equipment, upgrade the current survey vessel equipment to have accurate data for dredging.

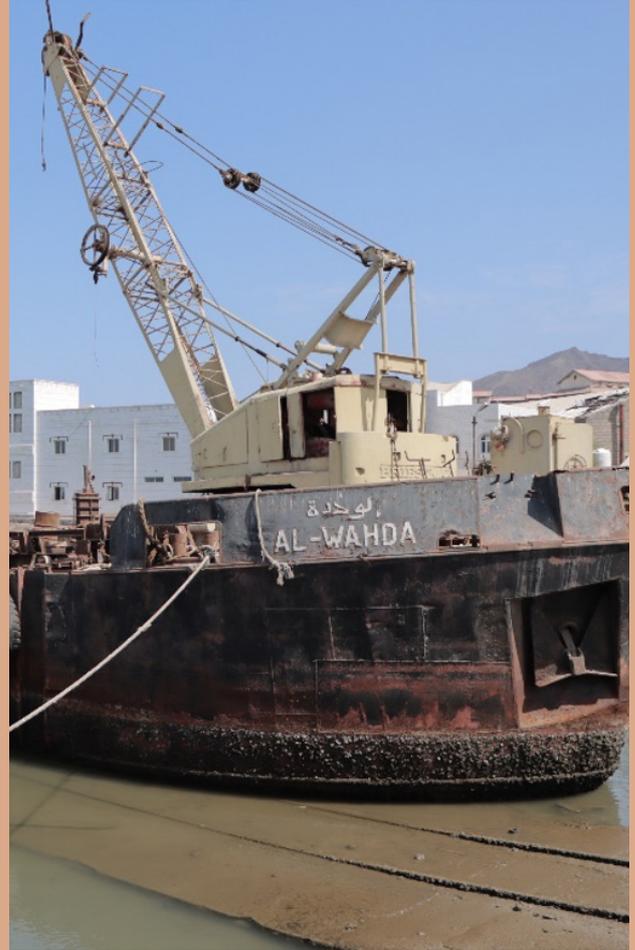
The workshop yard also stored a circa 1983 Al-Wahda grab hopper dredger (*see Figure 4*) and split barges—all of which are in poor condition and have been unused for years. Unable to use the survey vessel, the Port is unaware how much maintenance dredging must be performed and whether maintenance dredging work is required in the navigation channel and berths. Discussions revealed, however, that despite not knowing the conditions, there have not been any issues like the unavailability of berths, or damage to arriving or departing vessels.

Figure 4: Al-Wahda Dredger | Photo: UNDP Yemen

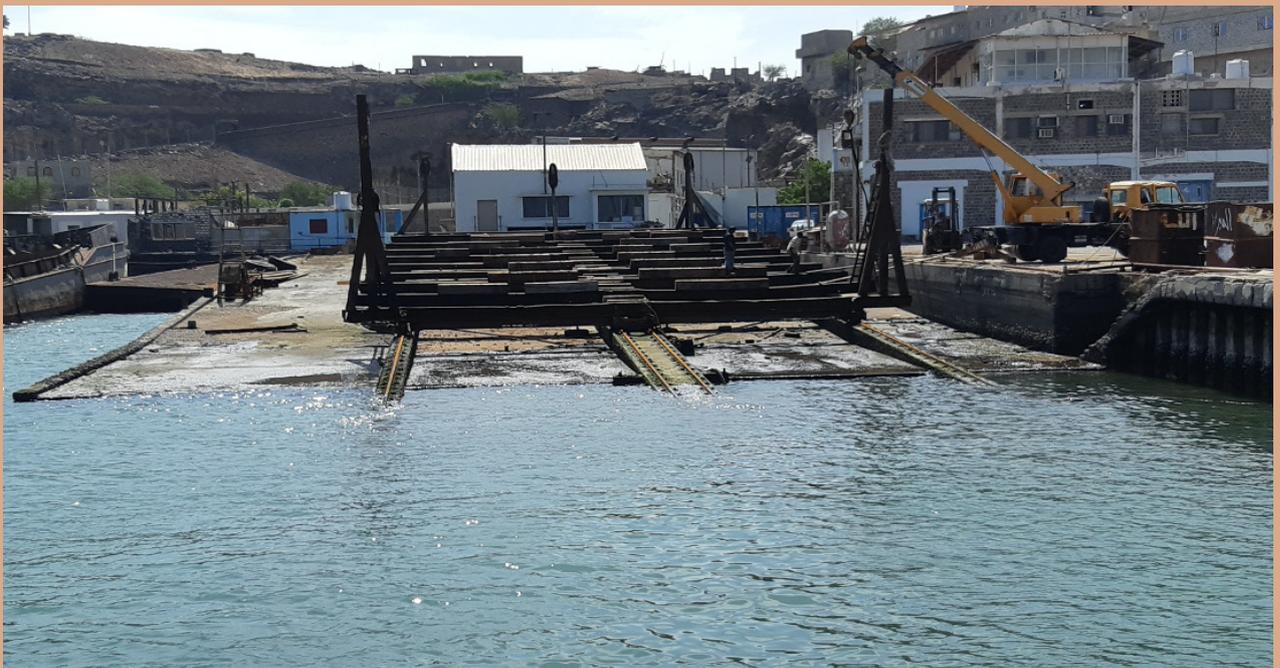
Figure 5: Main Slipway | Photo: Port of Rotterdam

The lower end of the slipway was damaged by bombing during the 1986 South Yemini Civil War, causing the YGAPC to be reluctant to fully load the slipway. However, the slipway's visible concrete and rail structure appeared in reasonable condition with only minor damages to the concrete and capable of being fully loaded. The Port's tugboats and other equipment are still being maintained on the slipway. Refer to Section 5.5.

A 2010 inspection report of the underwater slipway construction details only minor damages, but no major damage related to the bombing. It does not give reason to doubt the structural integrity of the slipway construction.

The slipway cradle is in moderate condition but requires maintenance and preservation. And the entire installation requires urgent maintenance to keep it operational: the winch's electrical installation (e.g., wiring, controls, etc.) is considerably outdated and unreliable, and the mechanical installation (e.g., cable drums, transmissions, etc.) is in reasonable condition given the year of construction. However, it appears that currently only the most essential lubrication work is carried out.

RECOMMENDATION: To clarify the presence and extent of the damages and the impact on the maximum load capacity of the slipway, perform a new inspection with results assessed by a structural engineer. In view of this assessment, this engineer must also draw up the inspection protocol.

RECOMMENDATION: Replace the entire electrical installation and perform major (replacement) maintenance on the mechanical installations. After this maintenance has been performed, the entire installation must be tested for maximum load capacity.

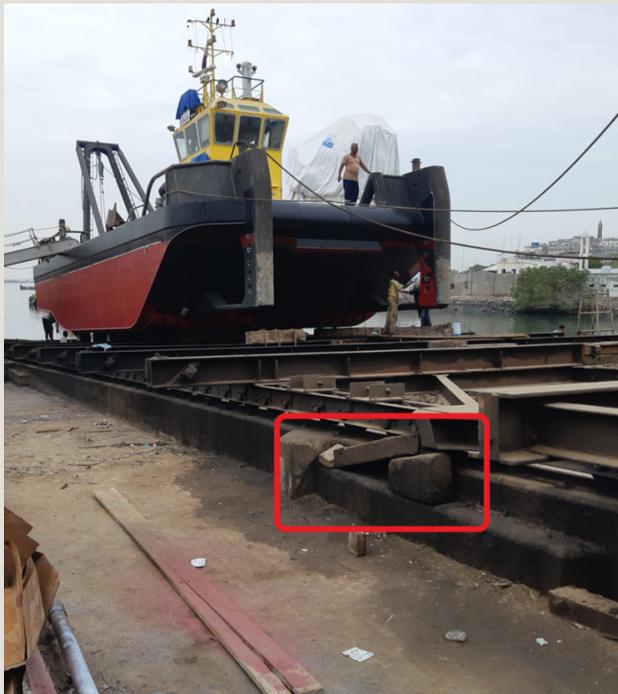
The slipway is provided with dogshore stops⁶ and precautions can be taken to prevent the cradle from rolling once ships are hauled up on the slipway. The assessment found that only provisional measures—use of loose concrete blocks to lock the cradle—are occurring, resulting in a serious safety issue. (See Figure 6.)

Figure 6: Main Slipway Safety Issue |
Photo: Port of Rotterdam

RECOMMENDATION: Purchase appropriate equipment such as a steel frame to ensure safe use of the slipway.

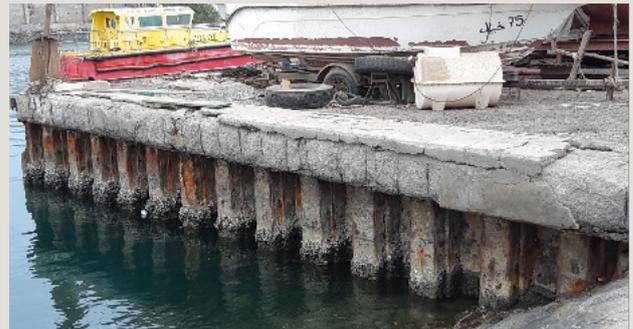
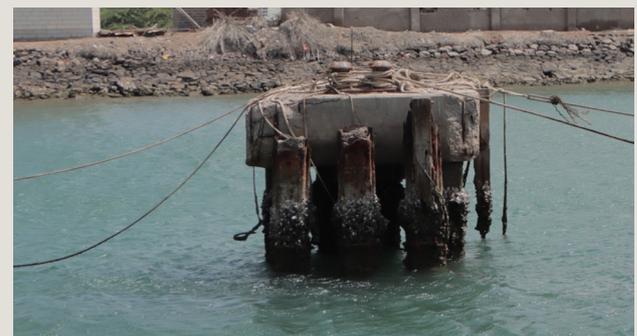
The quay wall to the west of the slipway is in a very poor condition. (See Figure 7.) The concrete capping beam is non-functional, there is no more fendering present, and the quay ladders are unsafe to use. The steel sheet piling shows significant damage above the waterline.

During the construction of the quay, cathodic protection based upon impressed current was applied; however, YGAPC indicated that the installation has not worked for years. Given the high salinity and average water temperature, significant corrosion damage below the waterline is expected upon further inspection. The inspection must include wall thickness and pitting measurements. Port of Rotterdam Corrosion Engineers can provide the inspection protocol and assess the results. The steel mooring posts and concrete dolphin structure on the east side of the slipway are deteriorated and unsuitable for use.

Figure 7: Quay Wall and Dolphin Main Slipway |
Photo: Port of Rotterdam

RECOMMENDATION: Conduct further inspection to determine if the quay damages are repairable or whether it must be replaced. It is also recommended to replace the dolphins.

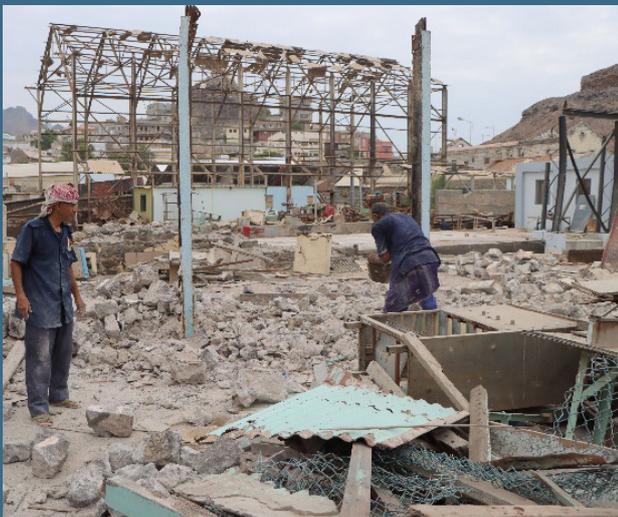
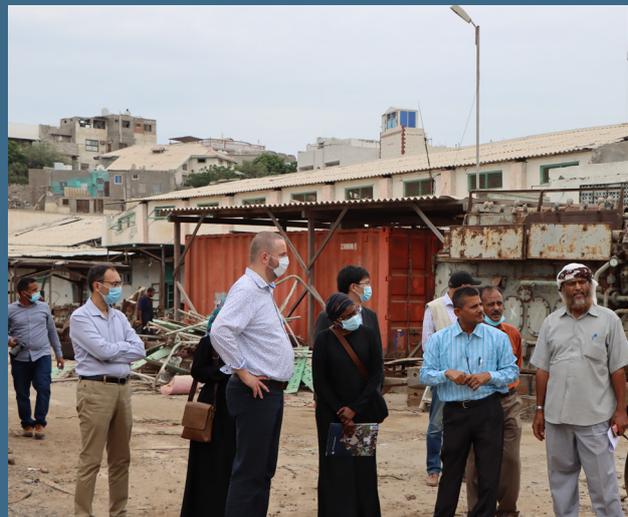
The yard contains several workshops with considerable war-induced damage to the marine workshop and a destroyed carpentry workshop. It is critical that both workshops are rebuilt as marine and carpentry services are major deliverables for the Technical Department. A detailed design for the marine workshop has been prepared by YGAPC.

Figure 8: Damaged Workshops | Photos: UNDP Yemen

RECOMMENDATION: Remove all waste and scrap material from the yards and workshops to prevent safety issues and increase work efficiency.

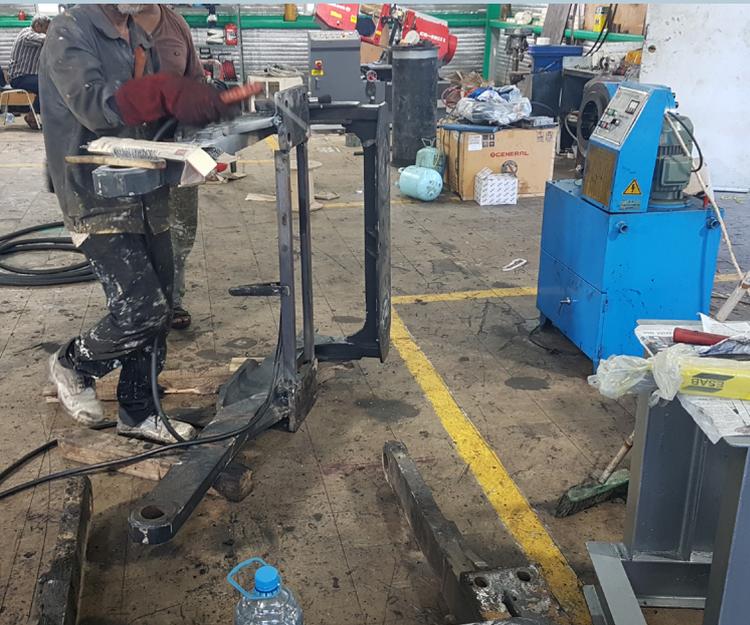
Figure 15: Repair of Rear Suspension of Kalmar Tractor (Warranty issue) | Photo: Solid Port Solutions

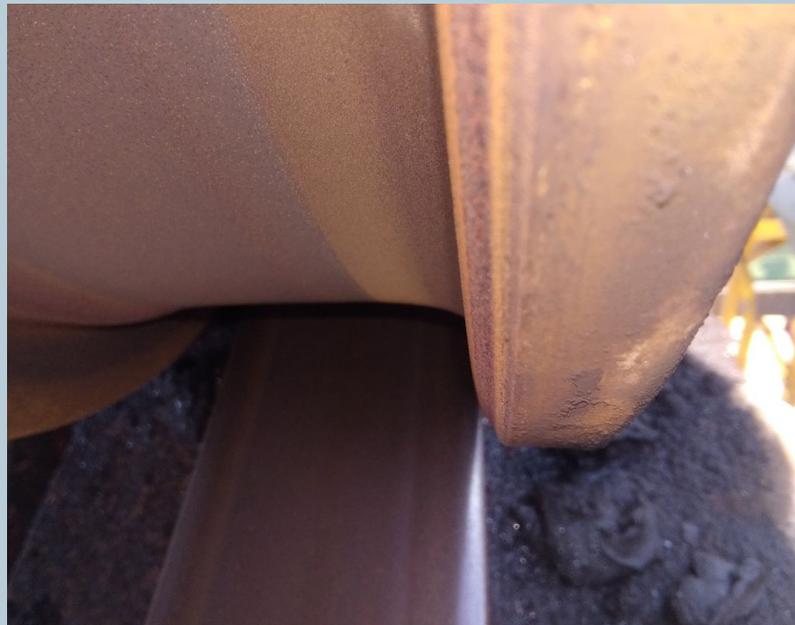
Figure 16: Misaligned Liebherr Trolley Wheels | Photo: Port of Aden

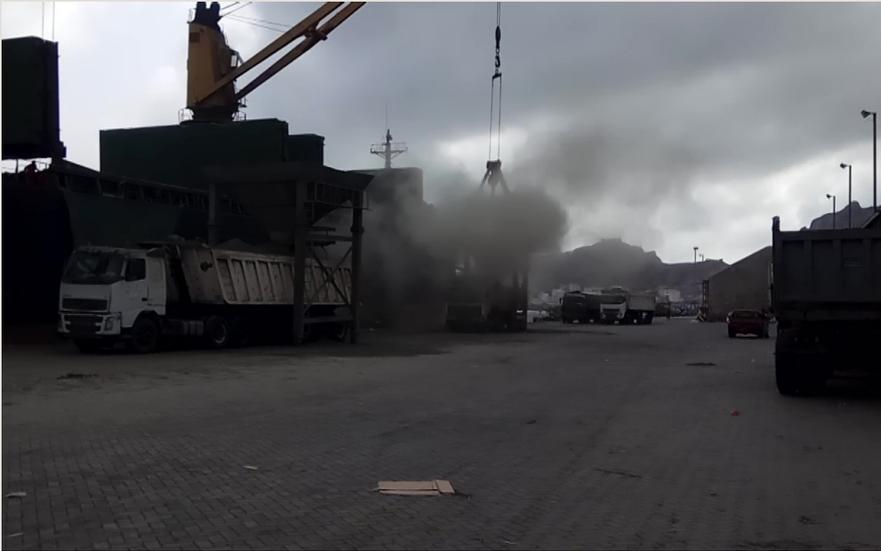
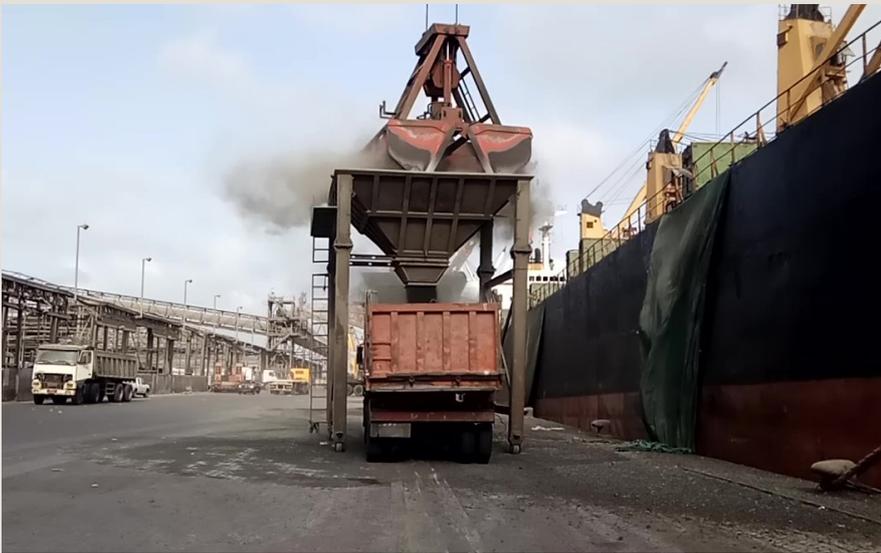
Figure 20: Particles Emission during Discharge of Cement | Photo: Port of Aden

RECOMMENDATION: The Port should purchase three eco-hoppers. Eco-hoppers are equipped with a special dust control system to minimise the escape of dust particles during the grab discharge cycle. Hoppers are mobile and can be transported to the various locations based upon where bulk cargo will be discharged in the Port's master plan.

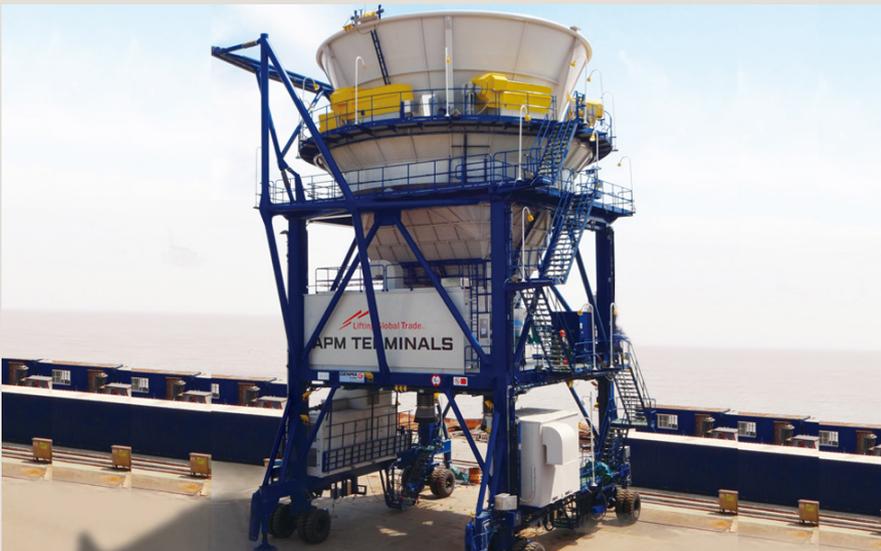
Figure 21: Eco Hoppers | Photo: Port of Aden

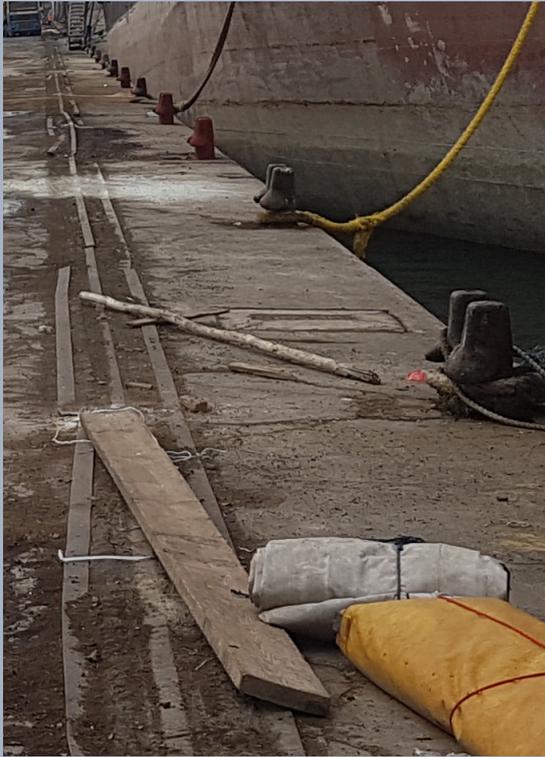
Figure 22: Cracks around Bollard Foundation | Photo: Port of Rotterdam

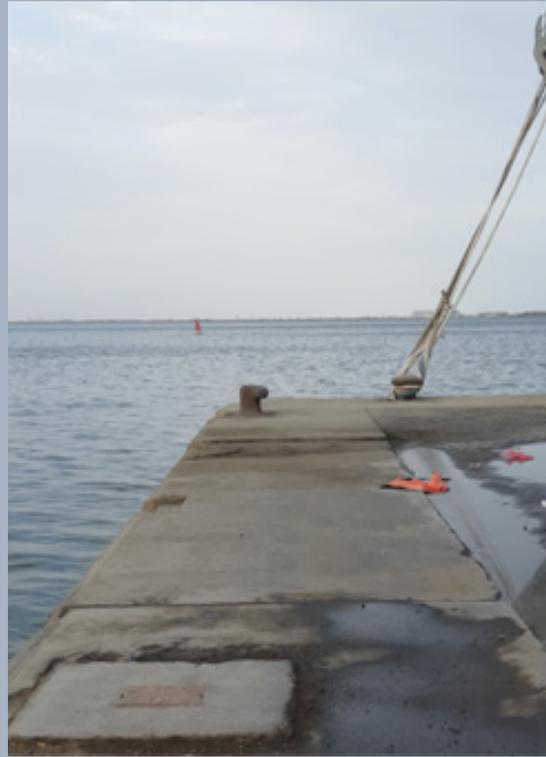
Figure 23: Vertical Deformation | Photo: Port of Rotterdam

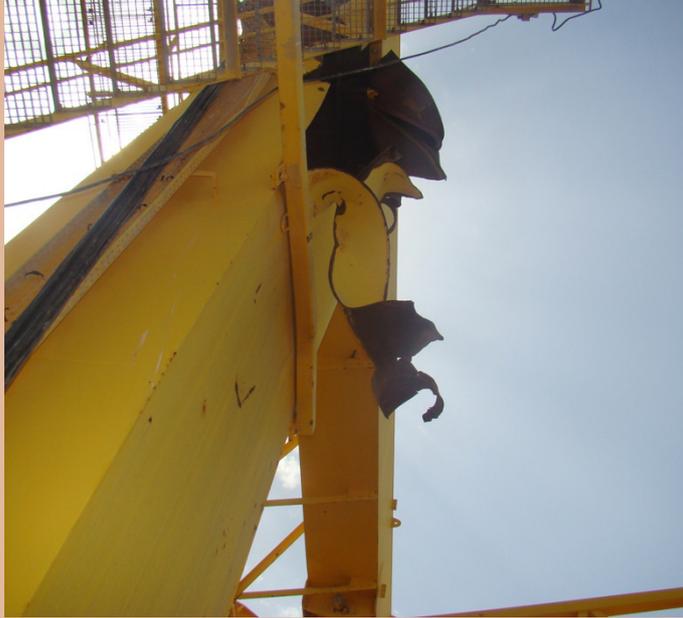
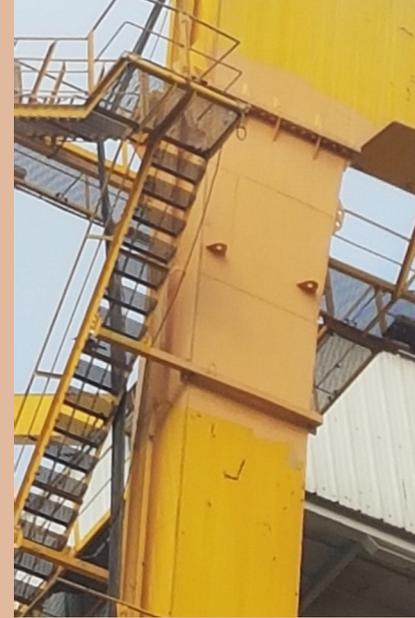
An inspection report from Aden Ports Development Company (APDC) contains descriptions of the cranes' defects. Provided by the YGAPC, the report shows that the two cranes are around 25 years old, having been installed on the quay around 1995.

The report indicated that the crane is in poor condition, but the only significant structural damage found was on one of the crane's legs. Damaged during the war, and repaired by YGAPC, the report indicated that it must be replaced in accordance with the supplier's design specification. It can be concluded from the report that a considerable amount of corrective maintenance is required to regain the cranes' full operation.

Figure 25: Damage to Liebherr Crane Before and After Repair | Photos: Port of Aden and Solid Port Solutions

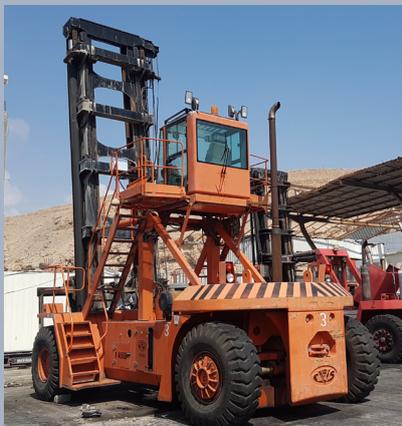
Figure 30: Equipment Waiting for Spare Parts | Photo: Solid Port Solutions

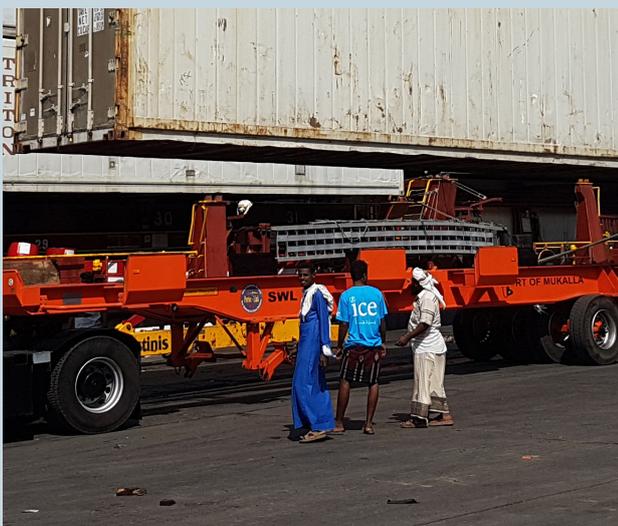
Figure 33: Lack of PPE by Port Users | Photo: Solid Port Solutions

RECOMMENDATION: Continually train the Port staff on personal, operational, and electrical safety.

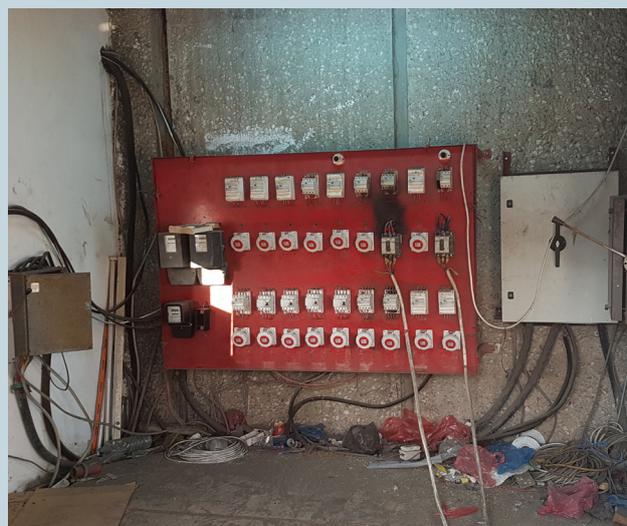
The safety of electrical installations needs to also improve as a fire resulting from a short circuit or any other faulty installation can have a devastating effect on the Ports operational readiness.

Figure 34: Problems with Electricity Safety | Photo: Solid Port Solutions
